**Mitch Witt Marine Surveying**

Survey of the Motor Yacht  
**"Motor Yacht XYZ"**  
1986 42' CHB Seamaster'

Survey of "Motor Vessel XYZ"

Pre-purchase Survey for: **Mr. John A Boat Owner** Ph  
711 Royal Lane, Great State  
Email

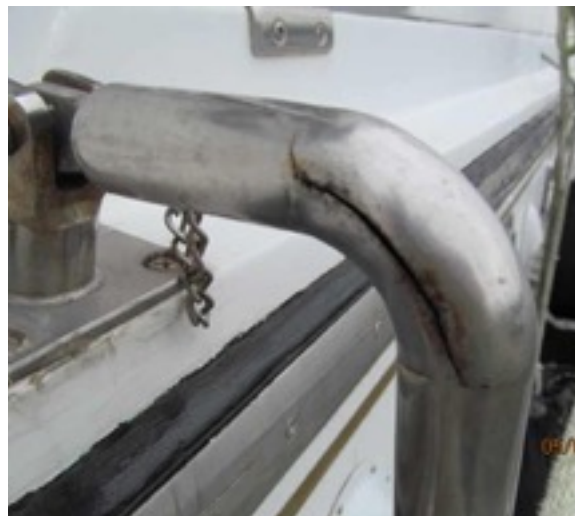
Boarding access port and starboard via "sliding" sections in rail which lock in place. A fold up boarding ladder hinges up and secures in place. Ladder fabricated of 1" SS  
Note Condition of ladder shown >>>  
**Repair essential - prior to navigation.**

Note: Standoffs have worn depressions in hull sides beneath port & Stbd board ladders

- 2 Repair cracked boarding ladder, port side. [See page 7.](#)
- 3 Insure all electrically powered bilge pumps work reliably and are adequately sized for this vessel.

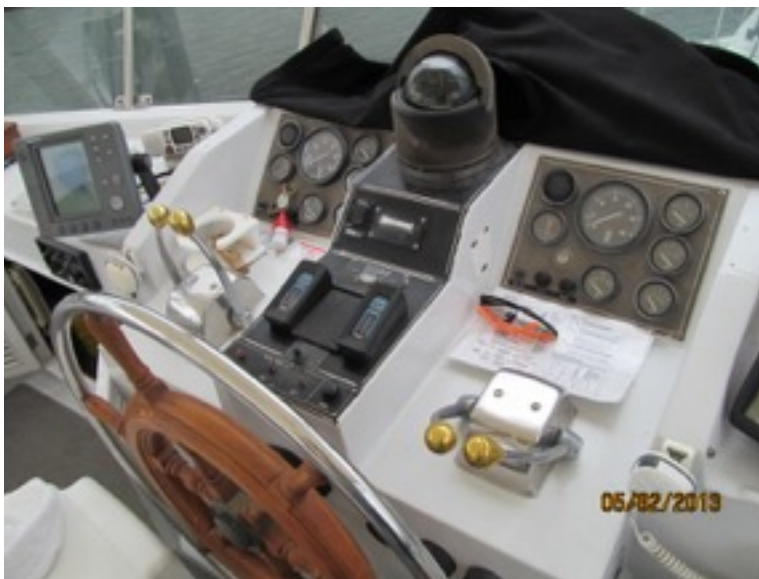
- Visibility: From the helm there is reasonably good visibility forward and side to side however visibility aft is hindered by aft deck hard top, tender and other items. Having two people aboard during operations is recommended and can be considered essential when operating astern propulsion. Wrap around forward swept tinted windscreen is cracked on the port corner.

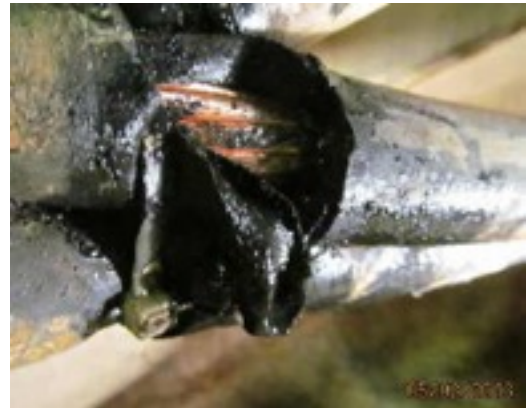
Original "00" size (+) conductors to port engine start motor and start solenoid are disintegrating, insulation completely broken down in one location near starter motor. > > > >

**⚡ Caution: Electrical Hazard ⚡**

**Essential: Replace original wiring for engine starting power (both engines) at the earliest opportunity. Battery switches for engine starting should be kept in "OFF" position until repairs are made.**

- 1 **Essential:** Replace original wiring for engine starting power (both engines) at the earliest opportunity. Battery switches for engine starting should be kept in "OFF" position until repairs are made.

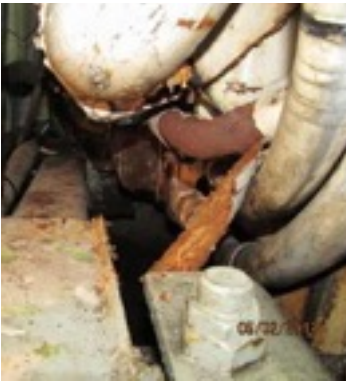
Engine exteriors show rust, paint peeling and are generally less than average condition.  
Good access to engines inboard, access to outboard sides is restricted.

Outboard Port Engine  
(Rust and peeling paint)

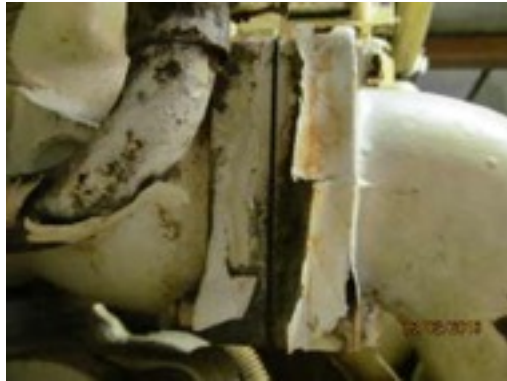
General Condition: Paint Peeling

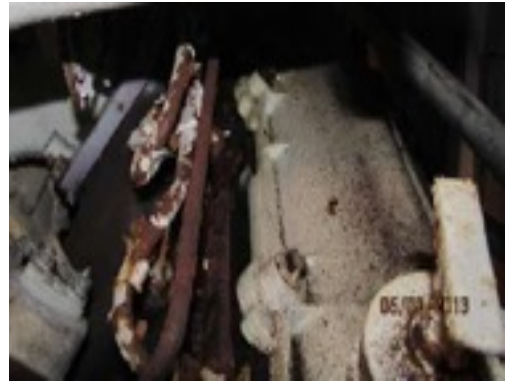
Rusted Fuel Lines

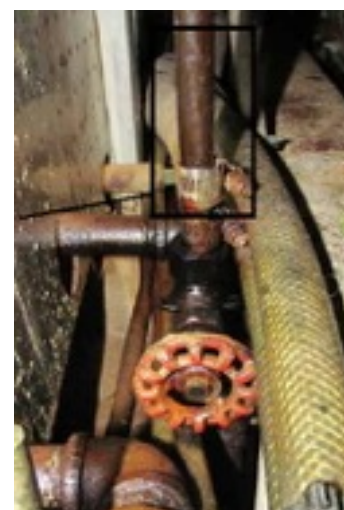
Each shows minor evidence of leaks. There are no guards installed around sight tubes.

Vinyl plastic tubing for fuel level > >
