**Mitch Witt Marine Surveying**

Survey of the Motor Yacht  
**"Motor Yacht XYZ"**  
1986 42' CHB Seamaster'

Survey of "Motor Vessel XYZ"

Pre-purchase Survey for: **Mr. John A Boat Owner** Ph  
711 Royal Lane, Great State  
Email

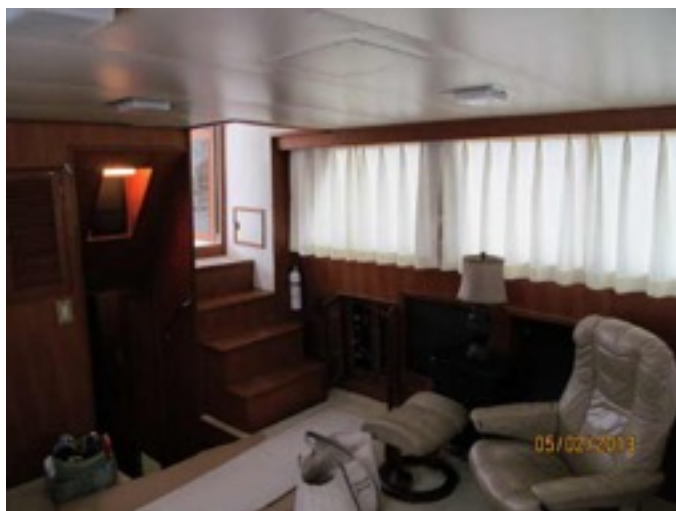
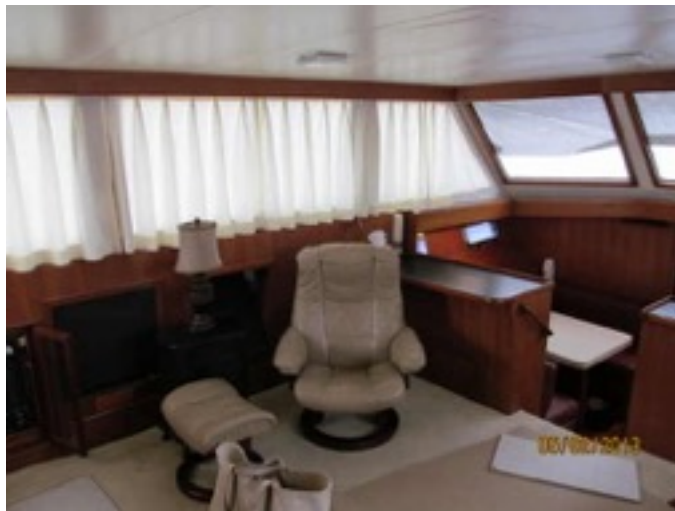
Several areas of paneling are in need of refinishing or replacing, most notably in the galley dining area.

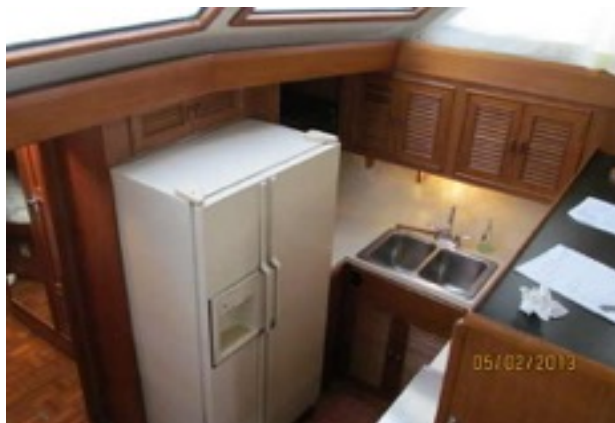
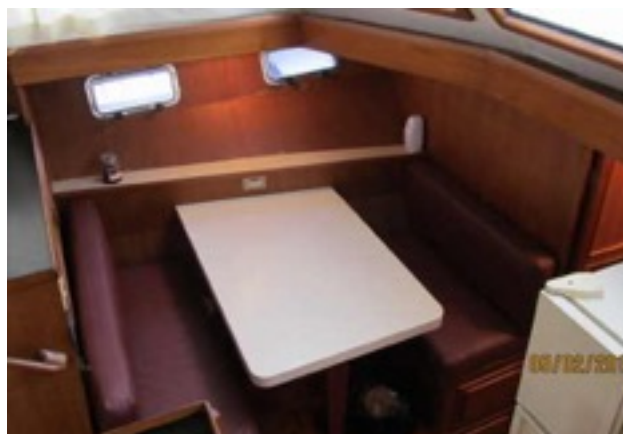
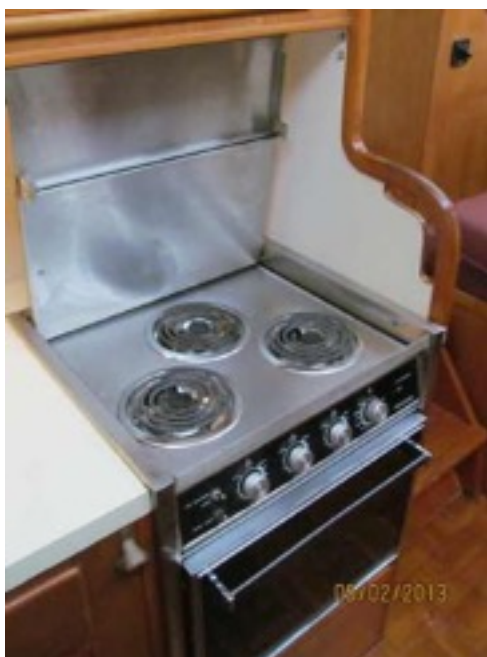
**Galley** includes a three burner 115 VAC stove with oven. Burners observed to heat to warm when energized. Microwave mounted in adjacent cabinets and full size Frigidare side by side freezer and fridge. There is reasonable storage space, cabinets and counter tops are clean and in good condition. Full size upright refrigerator/freezer and a smaller under counter unit both operating. An adjacent pick nick style table provides seating for 6. Fresh water pump operated delivering hot & cold water to galley and heads.

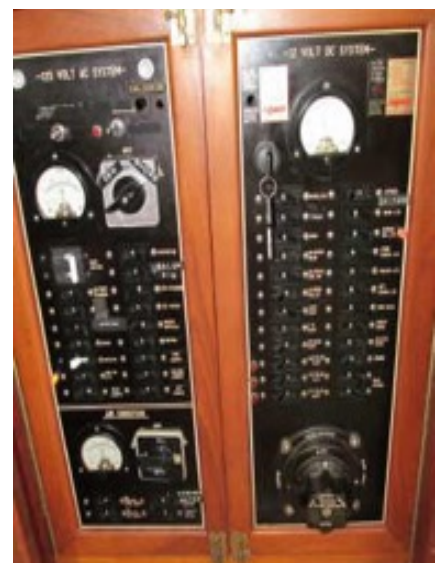
Panel DC and AC loads controlled from primary panel (original equipment) in main salon, port side. Panel includes analog current & voltage meters. Double pole main breaker and single pole breakers for branch circuits with selector switches for Shore Power vs Generator. All circuits were not individually tested during this inspection.

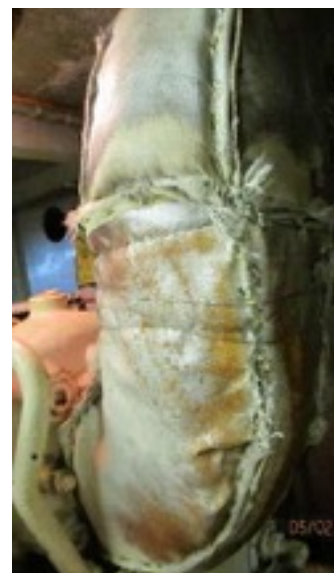
Exhaust Stbd side exhaust hose and clamps appear new. Insulated riser "lagging" is original material (both engines). Port side hose shows signs of cracking and is approaching end-of-life". No obvious signs of exhaust leaks either hose at time of this inspection. Portions of exhaust systems beneath lagging not inspected.

Ventilation of Engine Room Two, 3" 12 VDC exhaust fans installed aft and forward bulkheads of engine room. Neither fans observed to operate. Fresh air supply via large vents in hull sides. Recommend exhaust fans be made operational. Consideration should be given to replacing port side exhaust hose and clamps at the next scheduled maintenance interval.

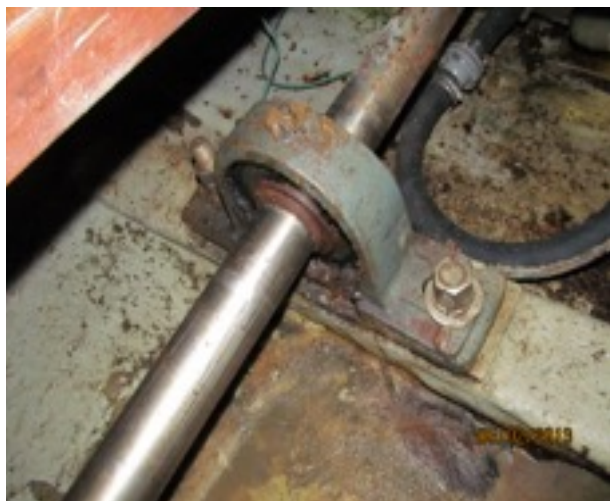
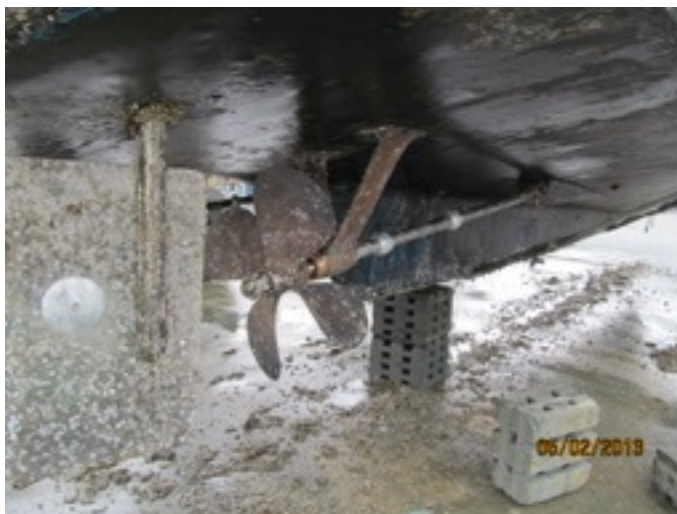
Transmissions ratio reported as 1.98 ~ 1  
Four blade bronze propellers, 26" diameter (pitch unidentified) installed on 2" stainless steel shafts. Little or no transverse movement in prop and shaft. Propellers in average condition. Each shaft supported by bronze "V" struts. In the bilge each shaft is supported by a Bearing with grease fitting. Shafts and Bearings show some rust. Shaft seals are difficult access.
